Flood Control Project Maintenance
2011 Structure Summary Report
Overall Unit and Item Ratings

Turlock Irrigation District Gomes Lake

Gomes Lake Pumping Plant

Flood Control Project Maintenance**Unit Cover Sheet****2011 Pumping Plant Inspection Results****Turlock Irrigation District Gomes Lake**

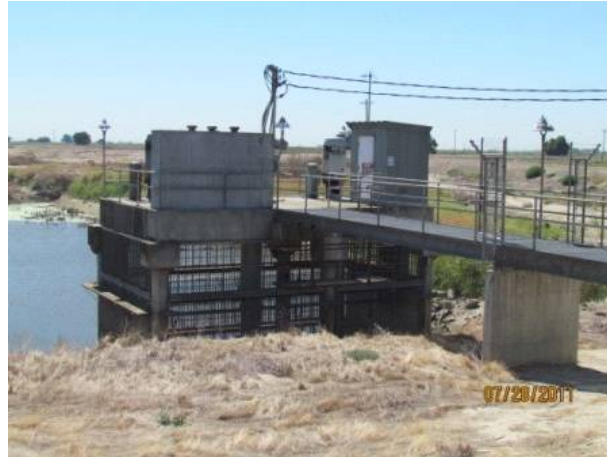
Levee Mile Report Line	3
Start Levee Mile	0.00
End Levee Mile	0.00
Location	
Category	Pump Stations
Item	Plant Building

View of the pumping plant.

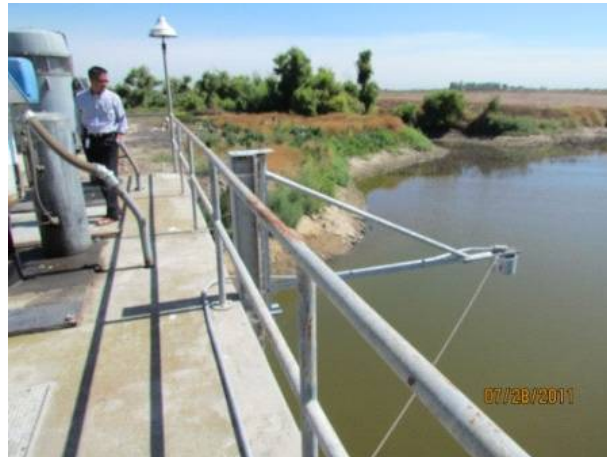
Levee Mile Report Line	5
Start Levee Mile	0.00
End Levee Mile	0.00
Location	
Category	Pump Stations
Item	Safety

View of the guard rails at the structure.

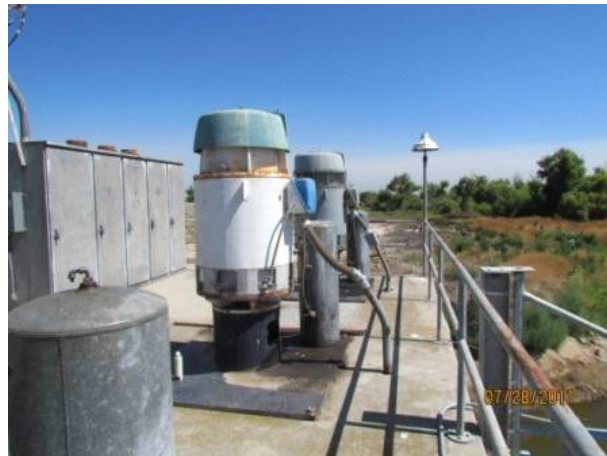
Levee Mile Report Line	7
Start Levee Mile	0.00
End Levee Mile	0.00
Location	
Category	Pump Stations
Item	Pumps

View of the pumps.

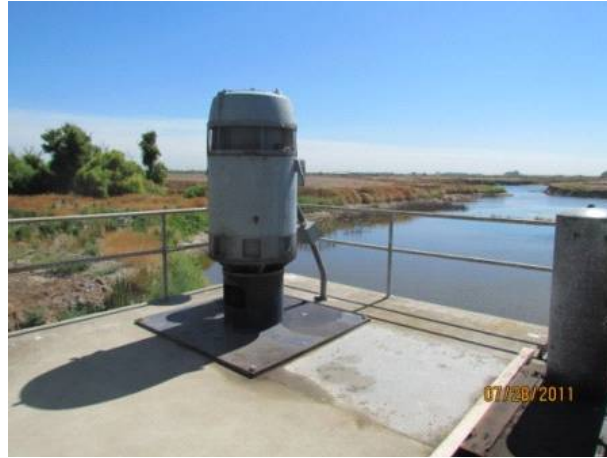
Levee Mile Report Line	7
Start Levee Mile	0.00
End Levee Mile	0.00
Location	
Category	Pump Stations
Item	Pumps
View of the pump that was tested during inspection.	
pkazi_t_20110810_091.jpg

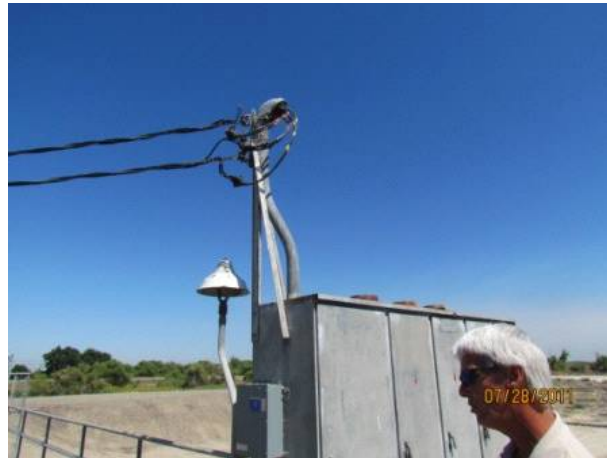
8	0.00	0.00	Pump Stations	Power		A	Item inspected visually only. Item was not operated during the inspection. Inspector Comments: The power source for this plant was delivered by the power grid rather than a generator and it appeared to be adequate and reliable.	37.481567 ° -121.046617 °	37.481567 ° -121.046617 °	8 Y
9	0.00	0.00	Pump Stations	Motors, Engines, Fans & Gear Reducers		N	Item inspected visually only. Item was not operated during the inspection. Inspector Comments: Other than the pump, no gear reducer or any other mechanical motor was present at the plant.	37.481567 ° -121.046617 °	37.481567 ° -121.046617 °	10

Levee Mile Report Line	8
Start Levee Mile	0.00
End Levee Mile	0.00
Location	
Category	Pump Stations
Item	Power
View of the power source at the plant.	
pkazi_t_20110810_092.jpg

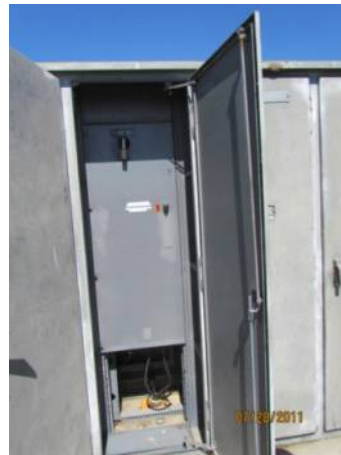
Levee Mile Report Line	10
Start Levee Mile	0.00
End Levee Mile	0.00
Location	
Category	Pump Stations
Item	Pump Control Systems
View of one of the power cabinets.	
pkazi_t_20110810_093.jpg

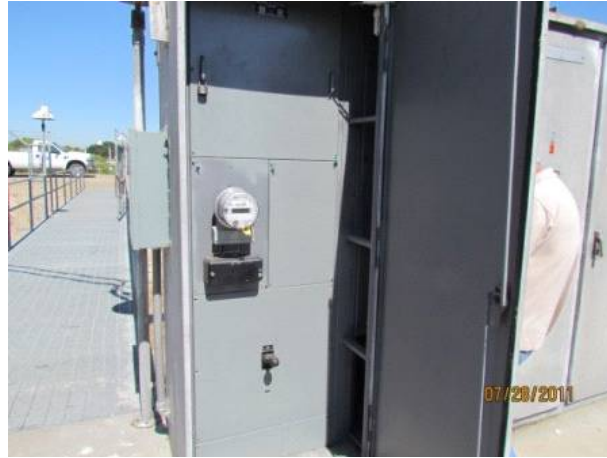
Levee Mile Report Line	10
Start Levee Mile	0.00
End Levee Mile	0.00
Location	
Category	Pump Stations
Item	Pump Control Systems

View of one of the power control systems.

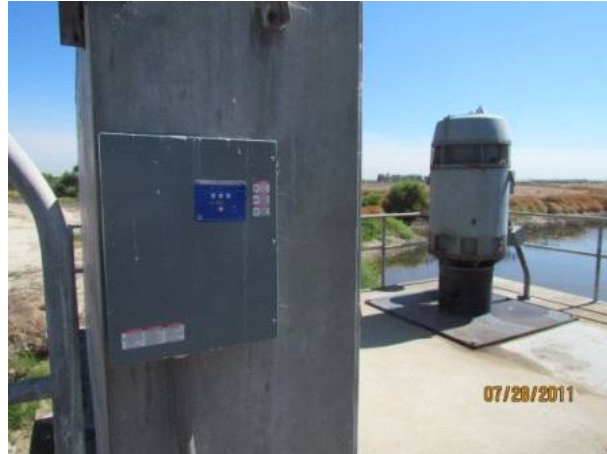
Levee Mile Report Line	10
Start Levee Mile	0.00
End Levee Mile	0.00
Location	
Category	Pump Stations
Item	Pump Control Systems

View of the control system.

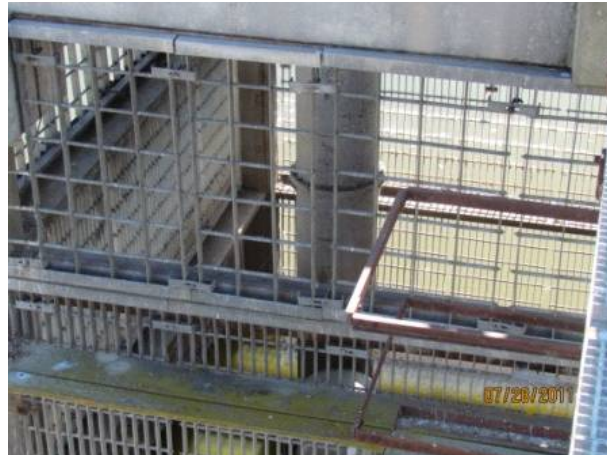
Levee Mile Report Line	11
Start Levee Mile	0.00
End Levee Mile	0.00
Location	
Category	Pump Stations
Item	Sumps/Wet Well

View of the wet well.

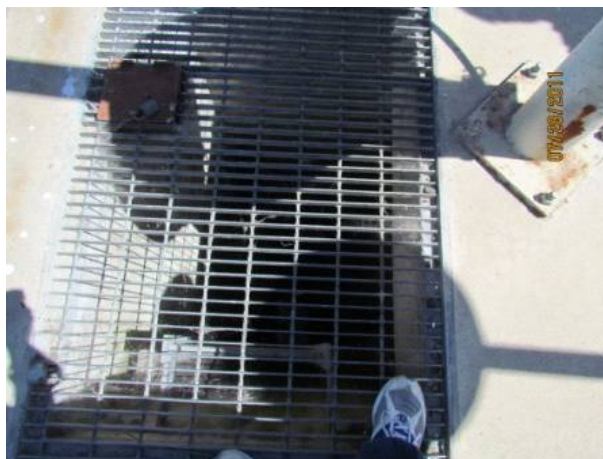
Levee Mile Report Line	14
Start Levee Mile	0.00
End Levee Mile	0.00
Location	
Category	Pump Stations
Item	Sluice / Slide Gates

View of the slide gate from the top of the structure.

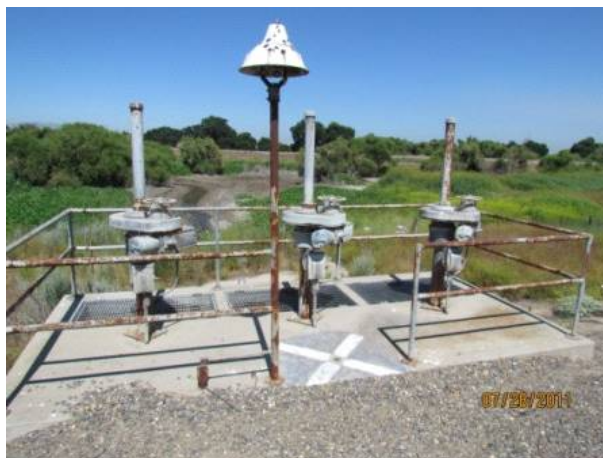
Levee Mile Report Line	16
Start Levee Mile	0.00
End Levee Mile	0.00
Location	
Category	Pump Stations
Item	Manual Gate Operators

View of the manual gates.

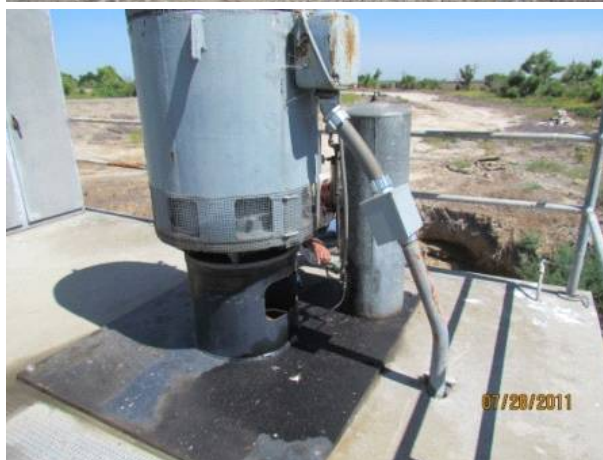
Levee Mile Report Line	17
Start Levee Mile	0.00
End Levee Mile	0.00
Location	
Category	Pump Stations
Item	Other Metallic Items

17	0.00	0.00	Pump Stations	Other Metallic Items		A	Item inspected visually only. Item was not operated during the inspection. Inspector Comments: All the other metal parts in the plant appeared to be in good condition and showed very little corrosion or deterioration.	37.481567 ° -121.046617 °	37.481567 ° -121.046617 °	18 Y
18	0.00	0.00	Pump Stations	Flap Gates		A	Item inspected visually only. Item was not operated during the inspection. Inspector Comments: The flap gates appeared to be in good working condition and capable of performing as intended.	37.481567 ° -121.046617 °	37.481567 ° -121.046617 °	19
19	0.00	0.00	Pump Stations	Closure Structures		N	Item inspected visually only. Item was not operated during the inspection. Inspector Comments: No closure structure exists at this plant.	37.481567 ° -121.046617 °	37.481567 ° -121.046617 °	20

View of one of the pumps.

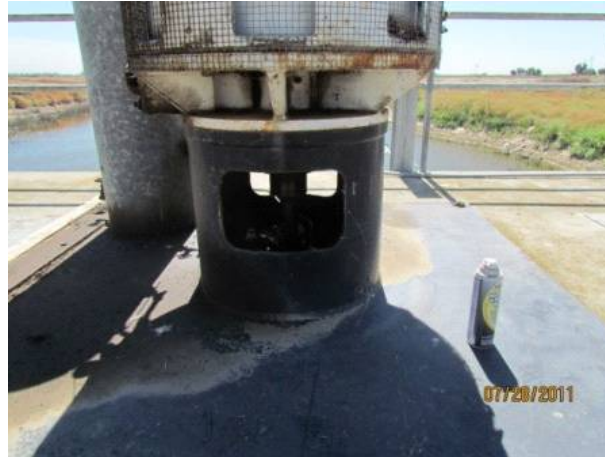
Levee Mile Report Line	17
Start Levee Mile	0.00
End Levee Mile	0.00
Location	
Category	Pump Stations
Item	Other Metallic Items

Detail view of the pump shows little corrosion.
